# Undrained resistance of pumice volcanic soil from the earthquake-induced Takanodai landslide, Kumamoto

Muhammad Umar, Gabriele Chiaro

Geo-disaster Mitigation Engineering

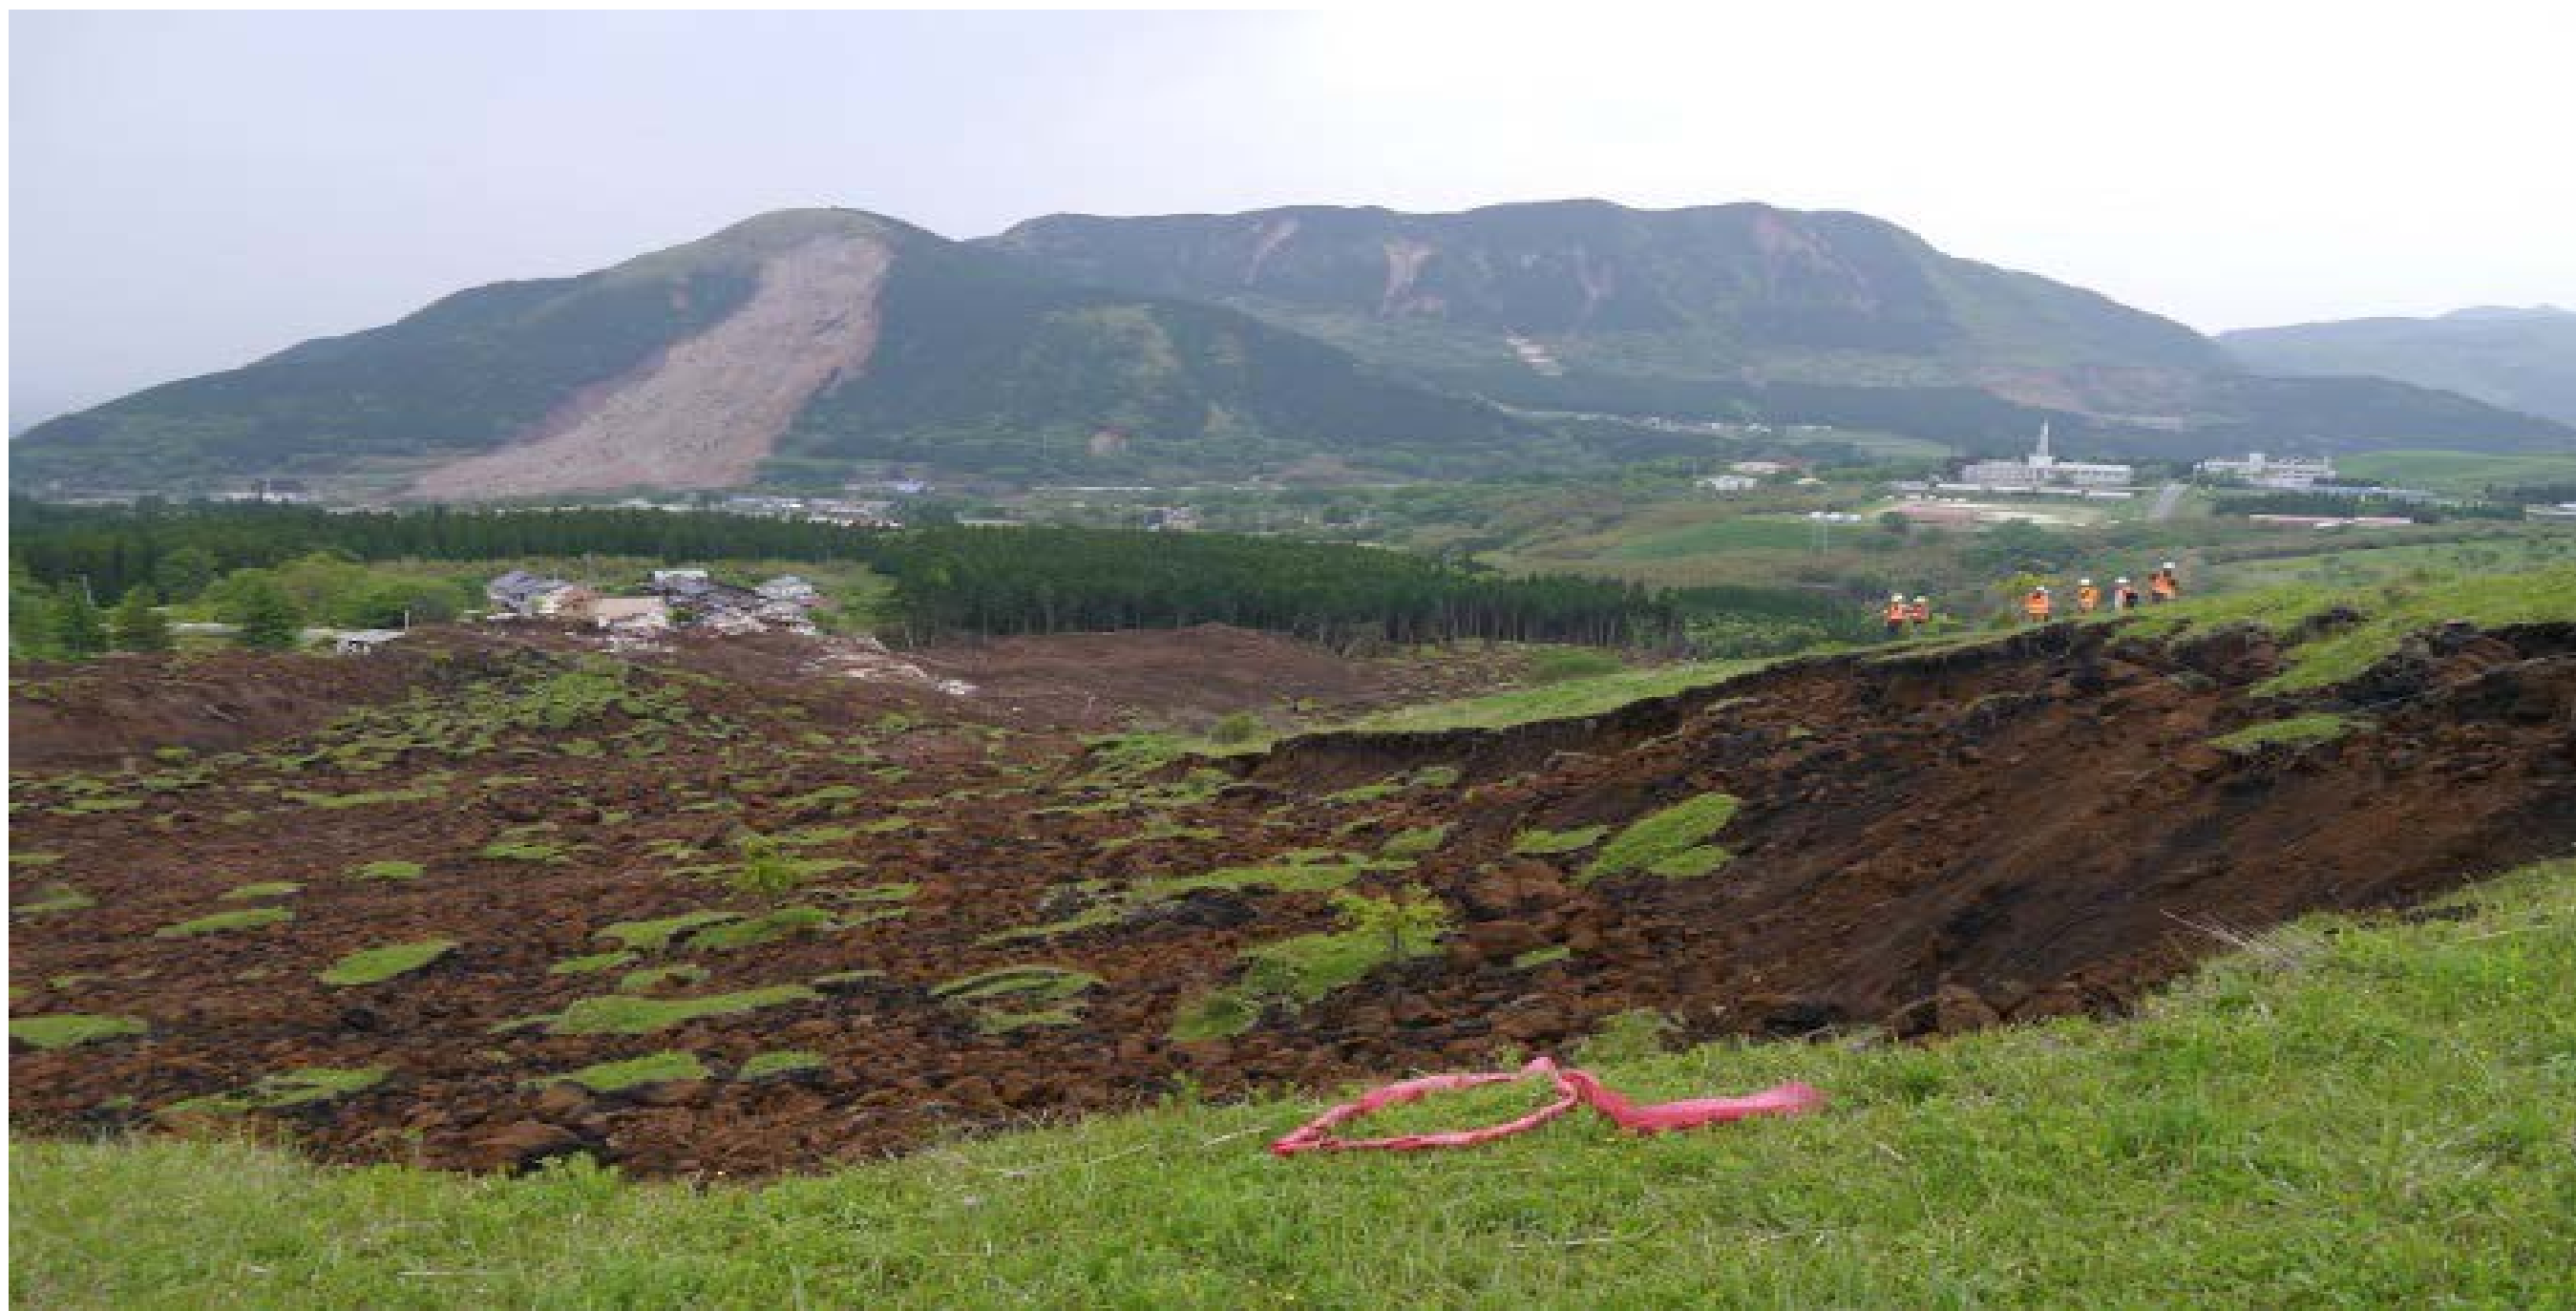
Fig. 1. View of the Takanodai landslide (looking downhill), with damaged houses and the large debris avalanche at Aso Ohashi Bridge visible in the distance

The 2016 Kumamoto Earthquakes caused a number of geo-disasters in the Mount Aso Caldera, including a large-scale flow-type slope failure known as the Takanodai landslide (Fig. 1) that destroyed 7 houses and killed 5 people. Between April and October 2016, the authors conducted a series of geotechnical damage surveys and field investigations in the Mount Aso Caldera, and retrieved samples of pumice volcanic soil to be tested in the laboratory.

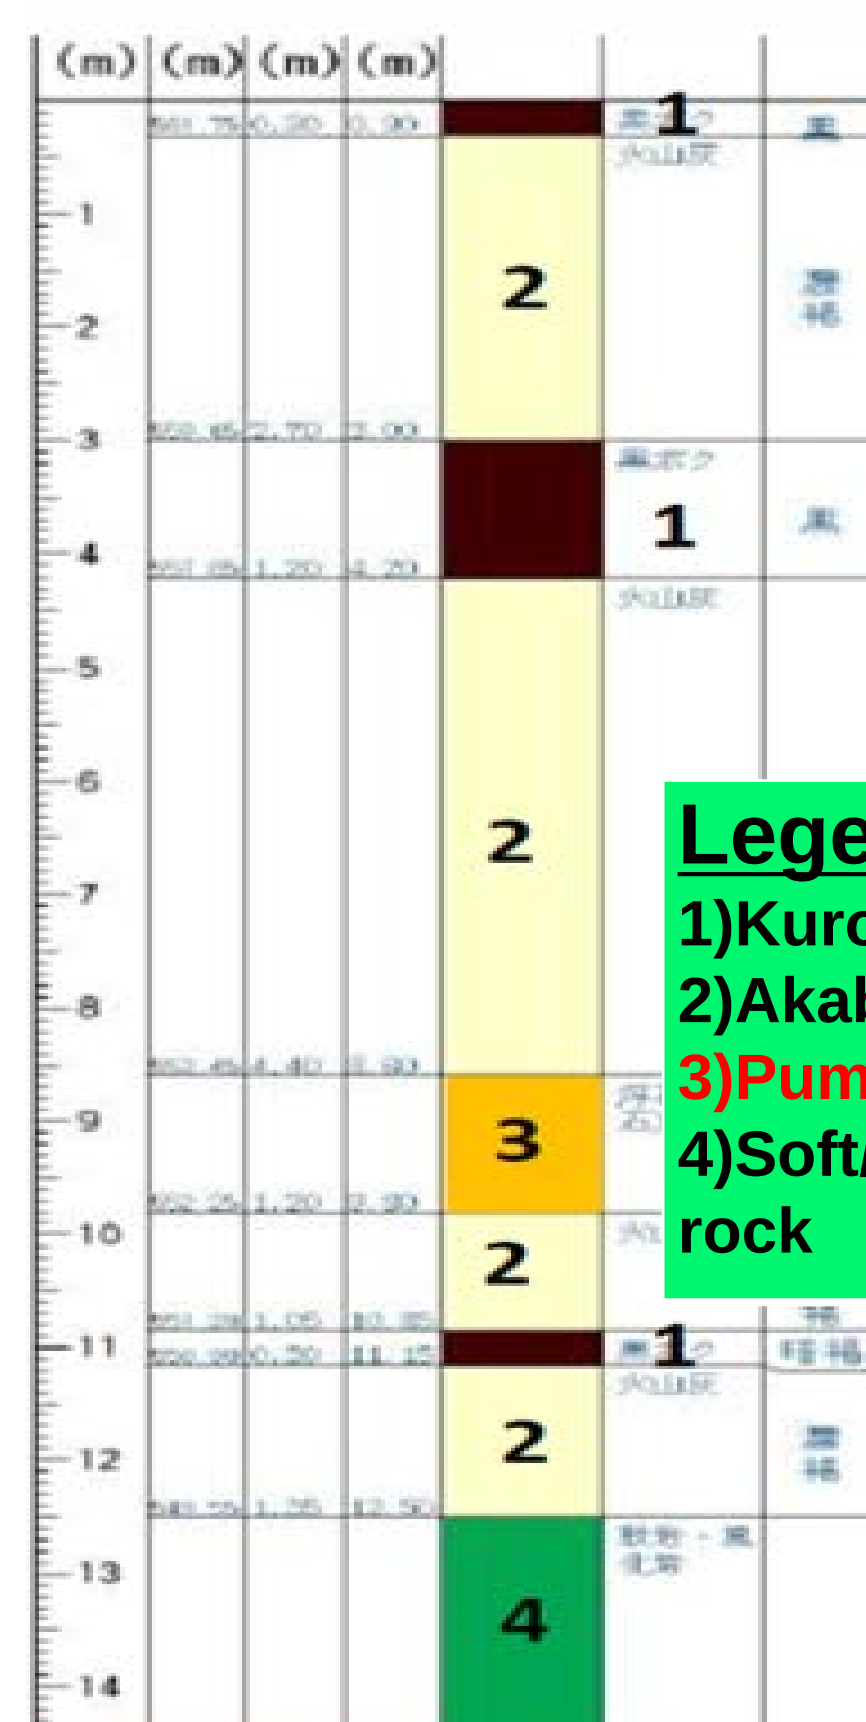
Fig. 4. Soil profile

A borehole describing a typical soil profile up to the depth of 14m and soil exposed in the trial pit are shown in Figs. 4 and 5, respectively.
