# Effect of road pavement thickness on liquefaction-induced settlement

Muhammad Mohsan

Geo-disaster Mitigation Engineering

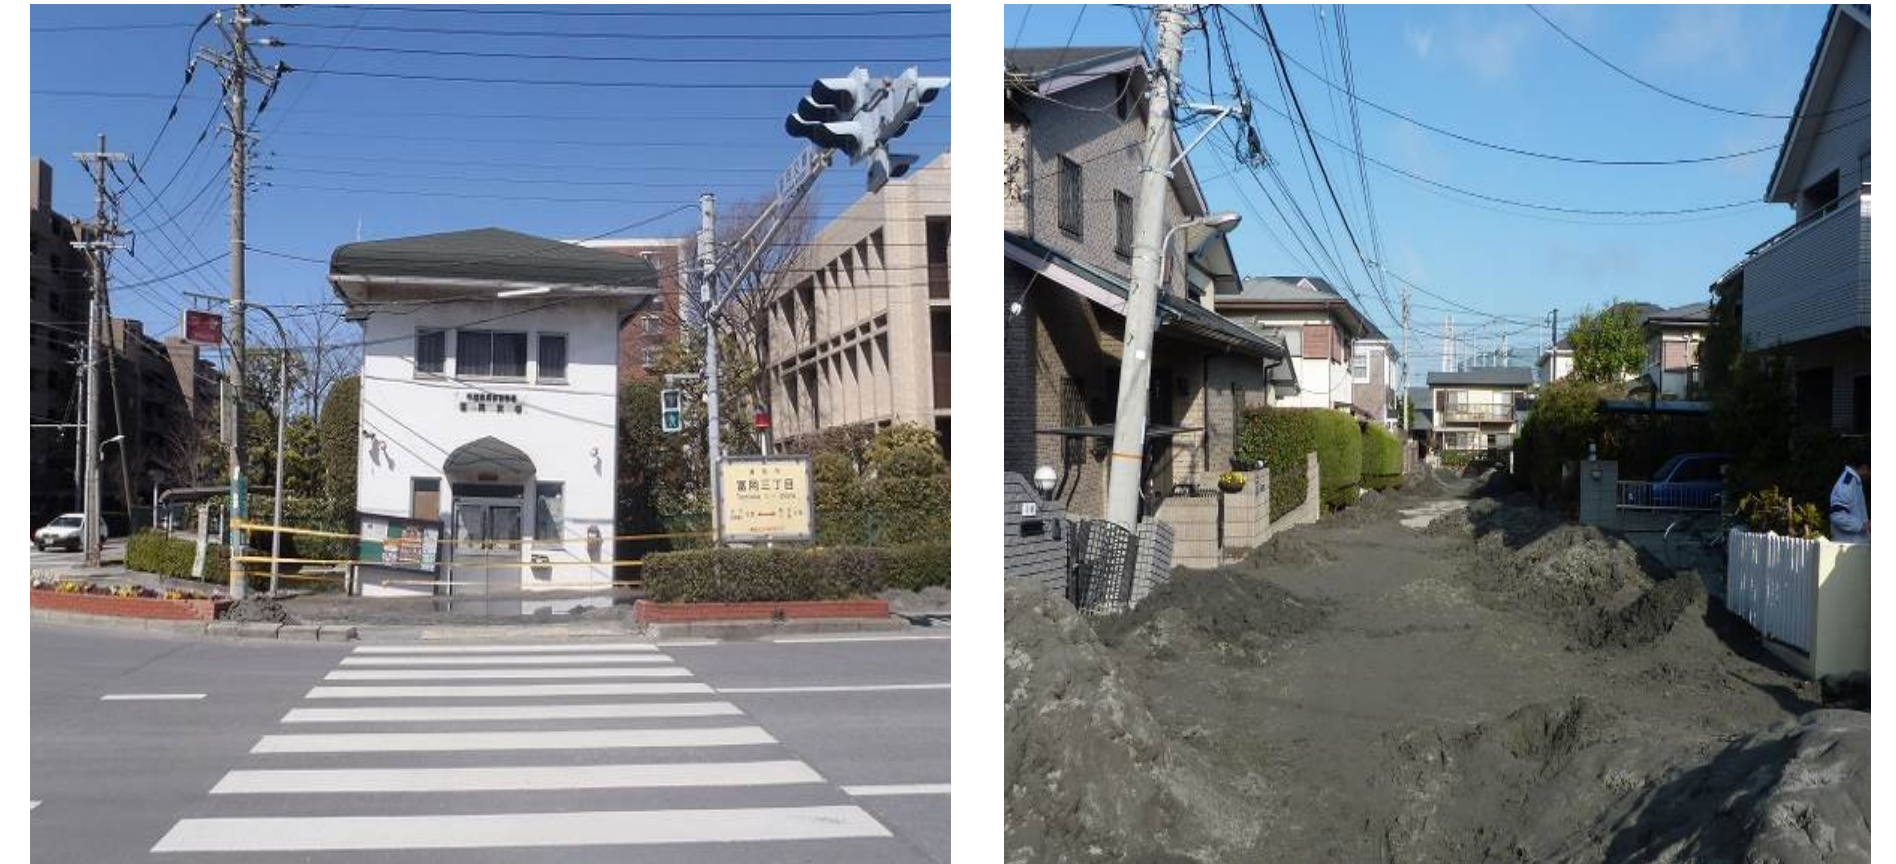
Fig. 1. Road condition of main road and residential road after the Great East Japan earthquake

Soil liquefaction is one of the most severe geotechnical issue related to the seismic shaking. The Great East Japan earthquake 2011 caused the severe liquefaction in Tokyo bay area including the ground subsidence, tilting of the structures, uplift of the light structure and damage to the road facilities(Fig. 1).It was reported that almost 42km<sup>2</sup> of the Tokyo Bay area severely damaged because of the liquefaction.

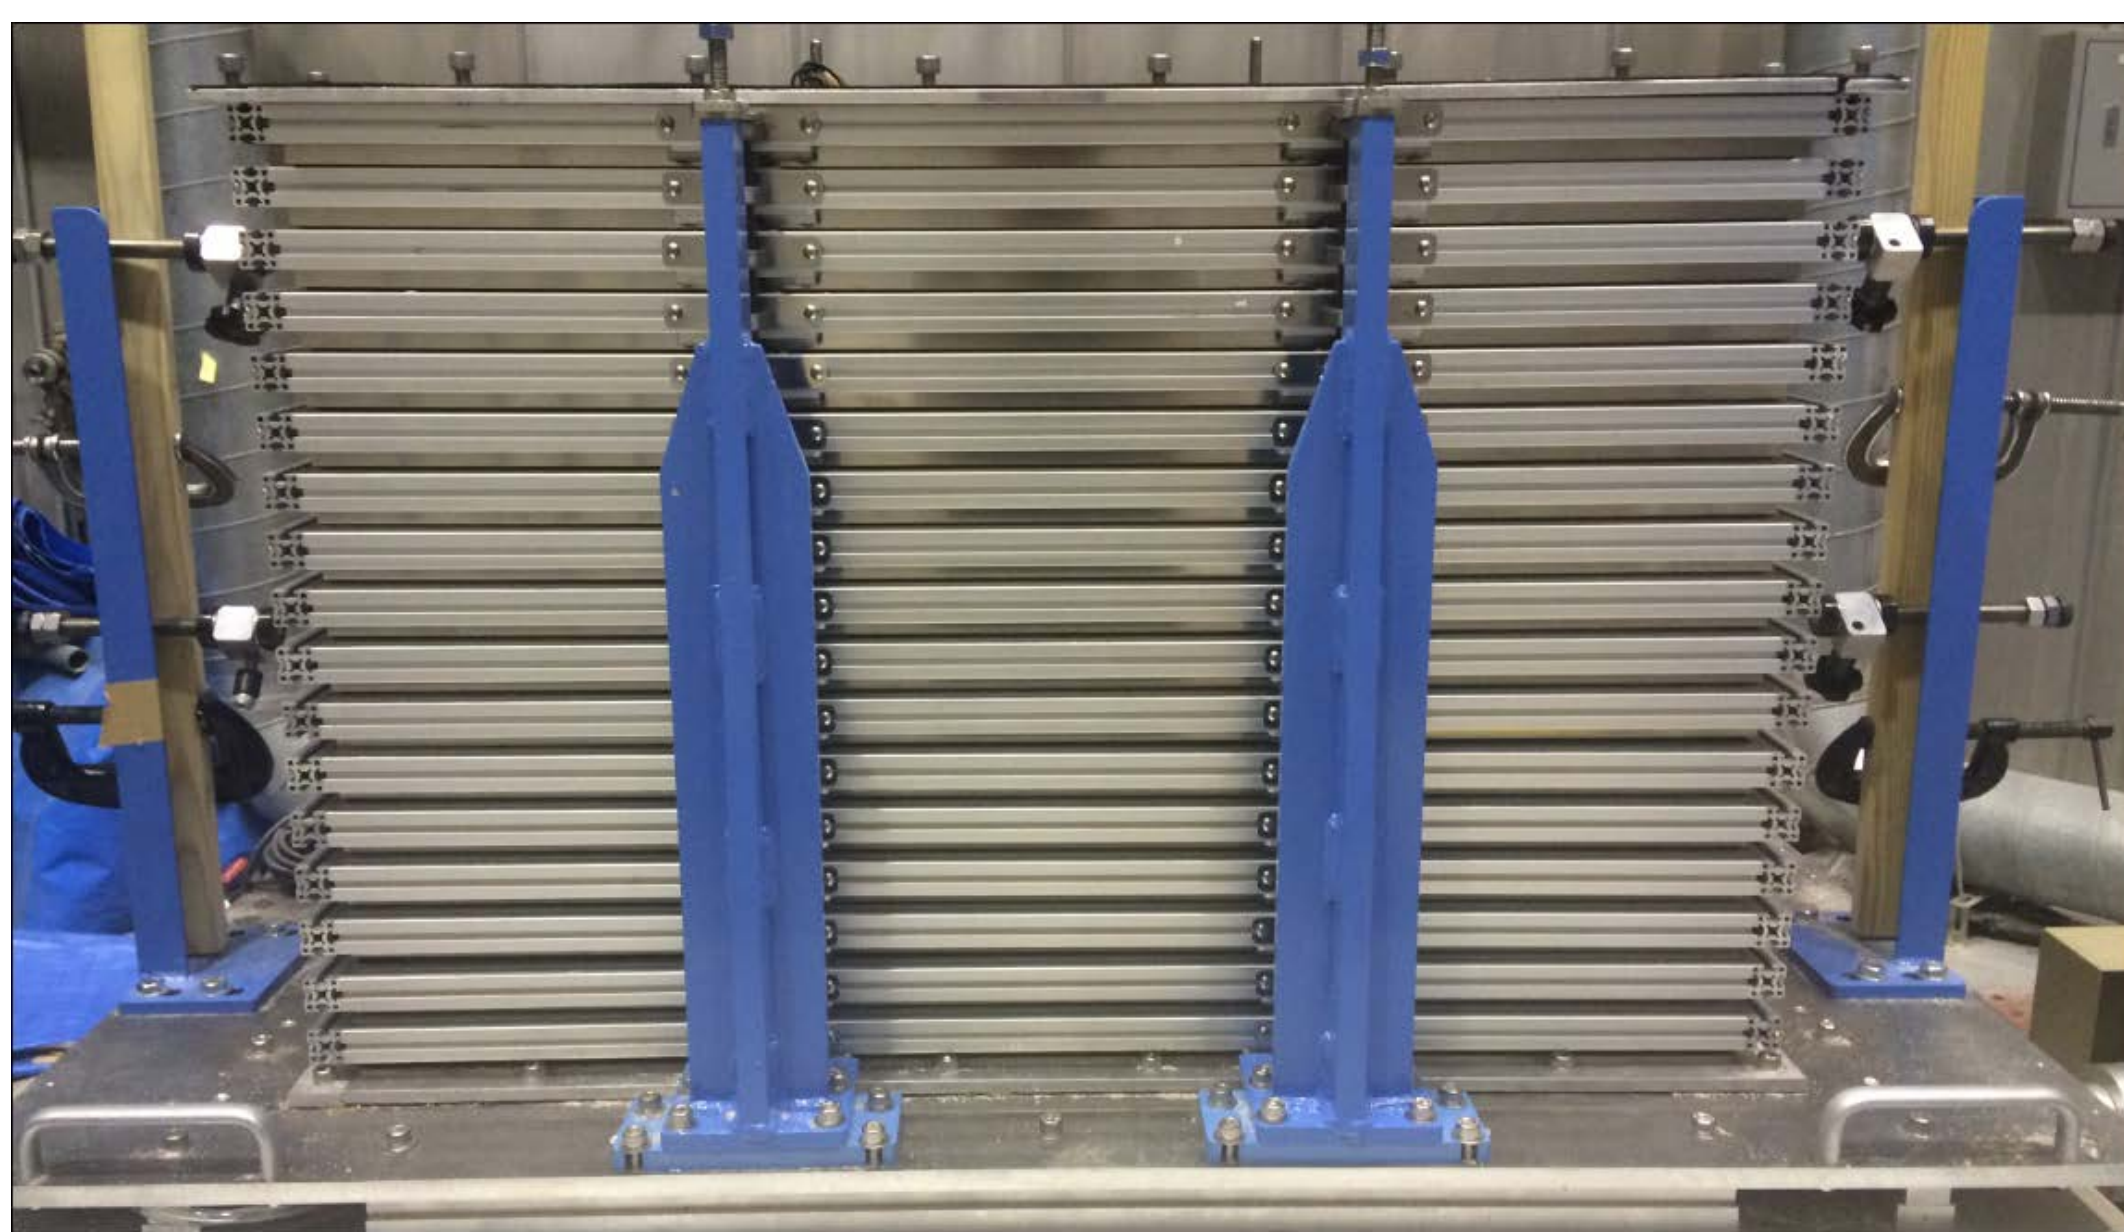
Fig. 2. Laminar soil box(100cm x 40cm x 70cm)

1-g shaking table model tests were conducted with the laminar soil (Fig.2 & Fig.3) box to reproduce the field conditions at lab scale to understand the disaster mechanism of the road facilities. The scale down factor for all the model tests were 1/20.

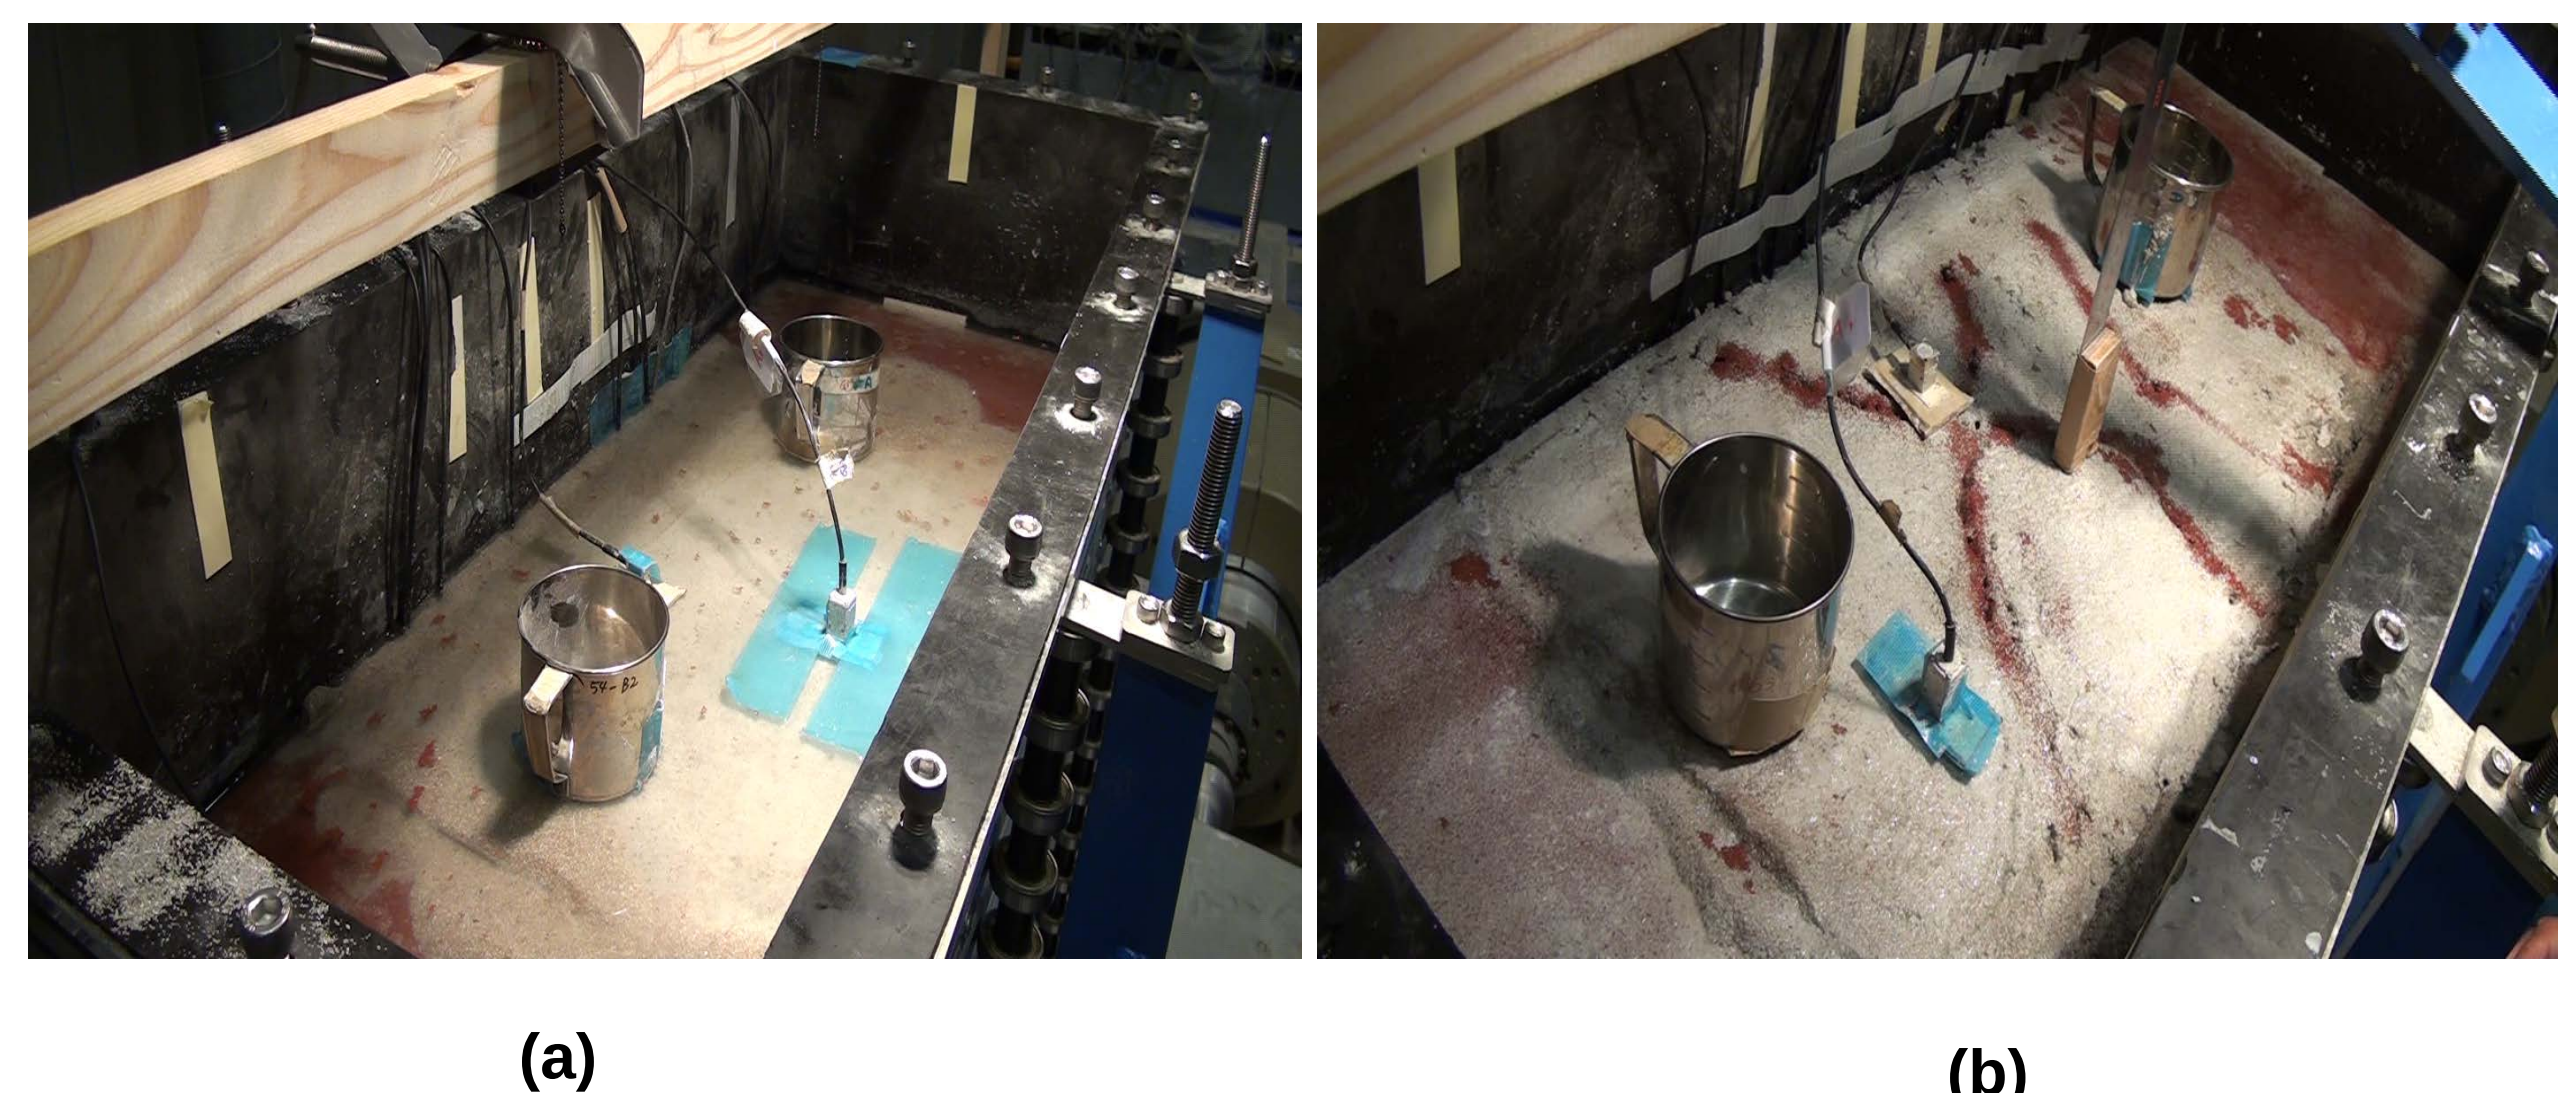
Fig. 6. (a) Main road model with thick pavement and (b) residential road model with thin pavement after 1-g shaking test
