# Cyclic degradation of Toyoura sand using advanced Torsional shear apparatus

Muhammad Umar

Geo-disaster Mitigation Engineering

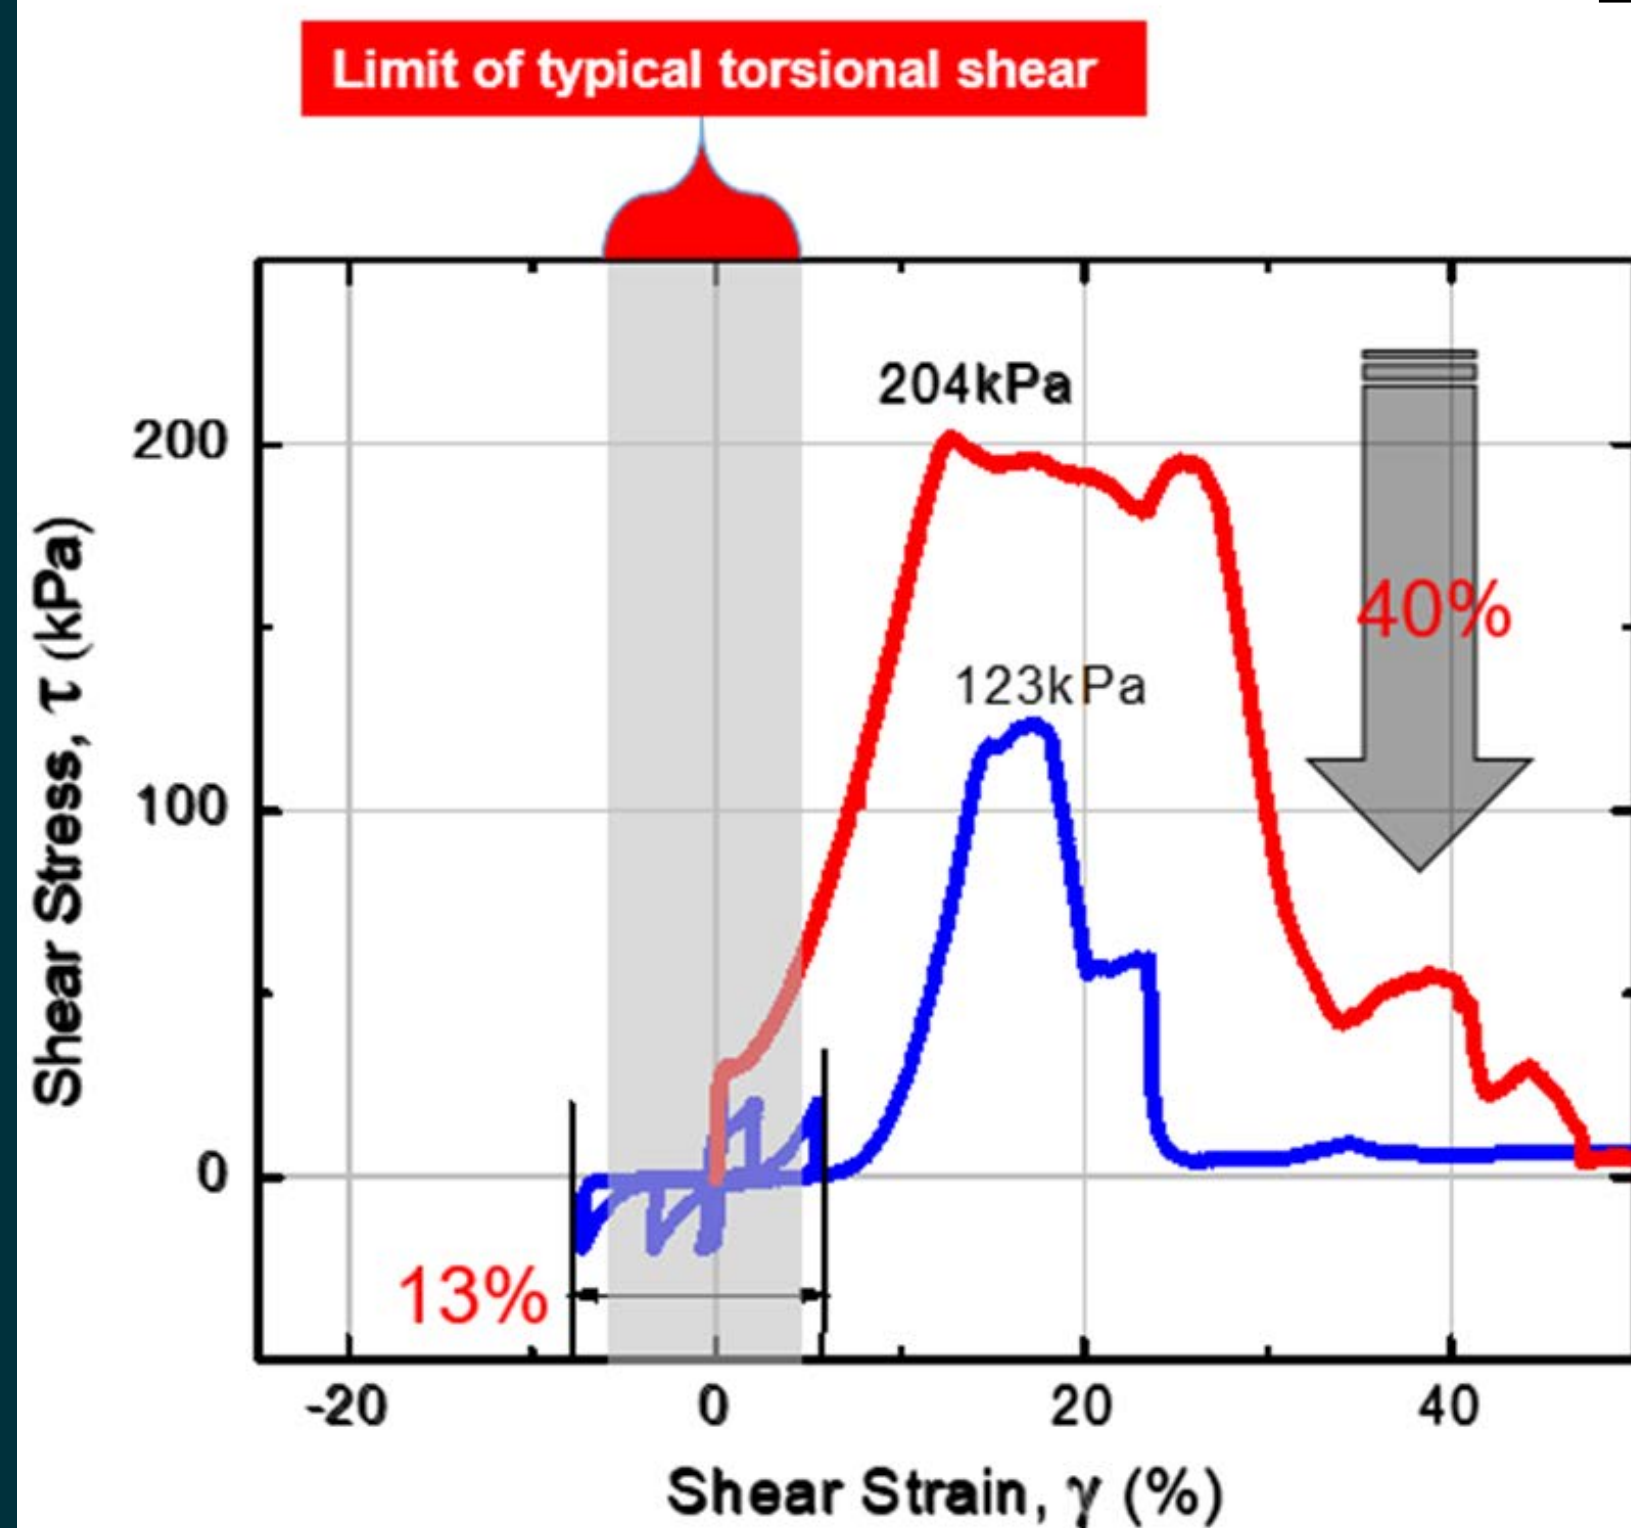
Toyouura sand showed drastic reduction in Undrained peak shear strength by cyclic damage strain

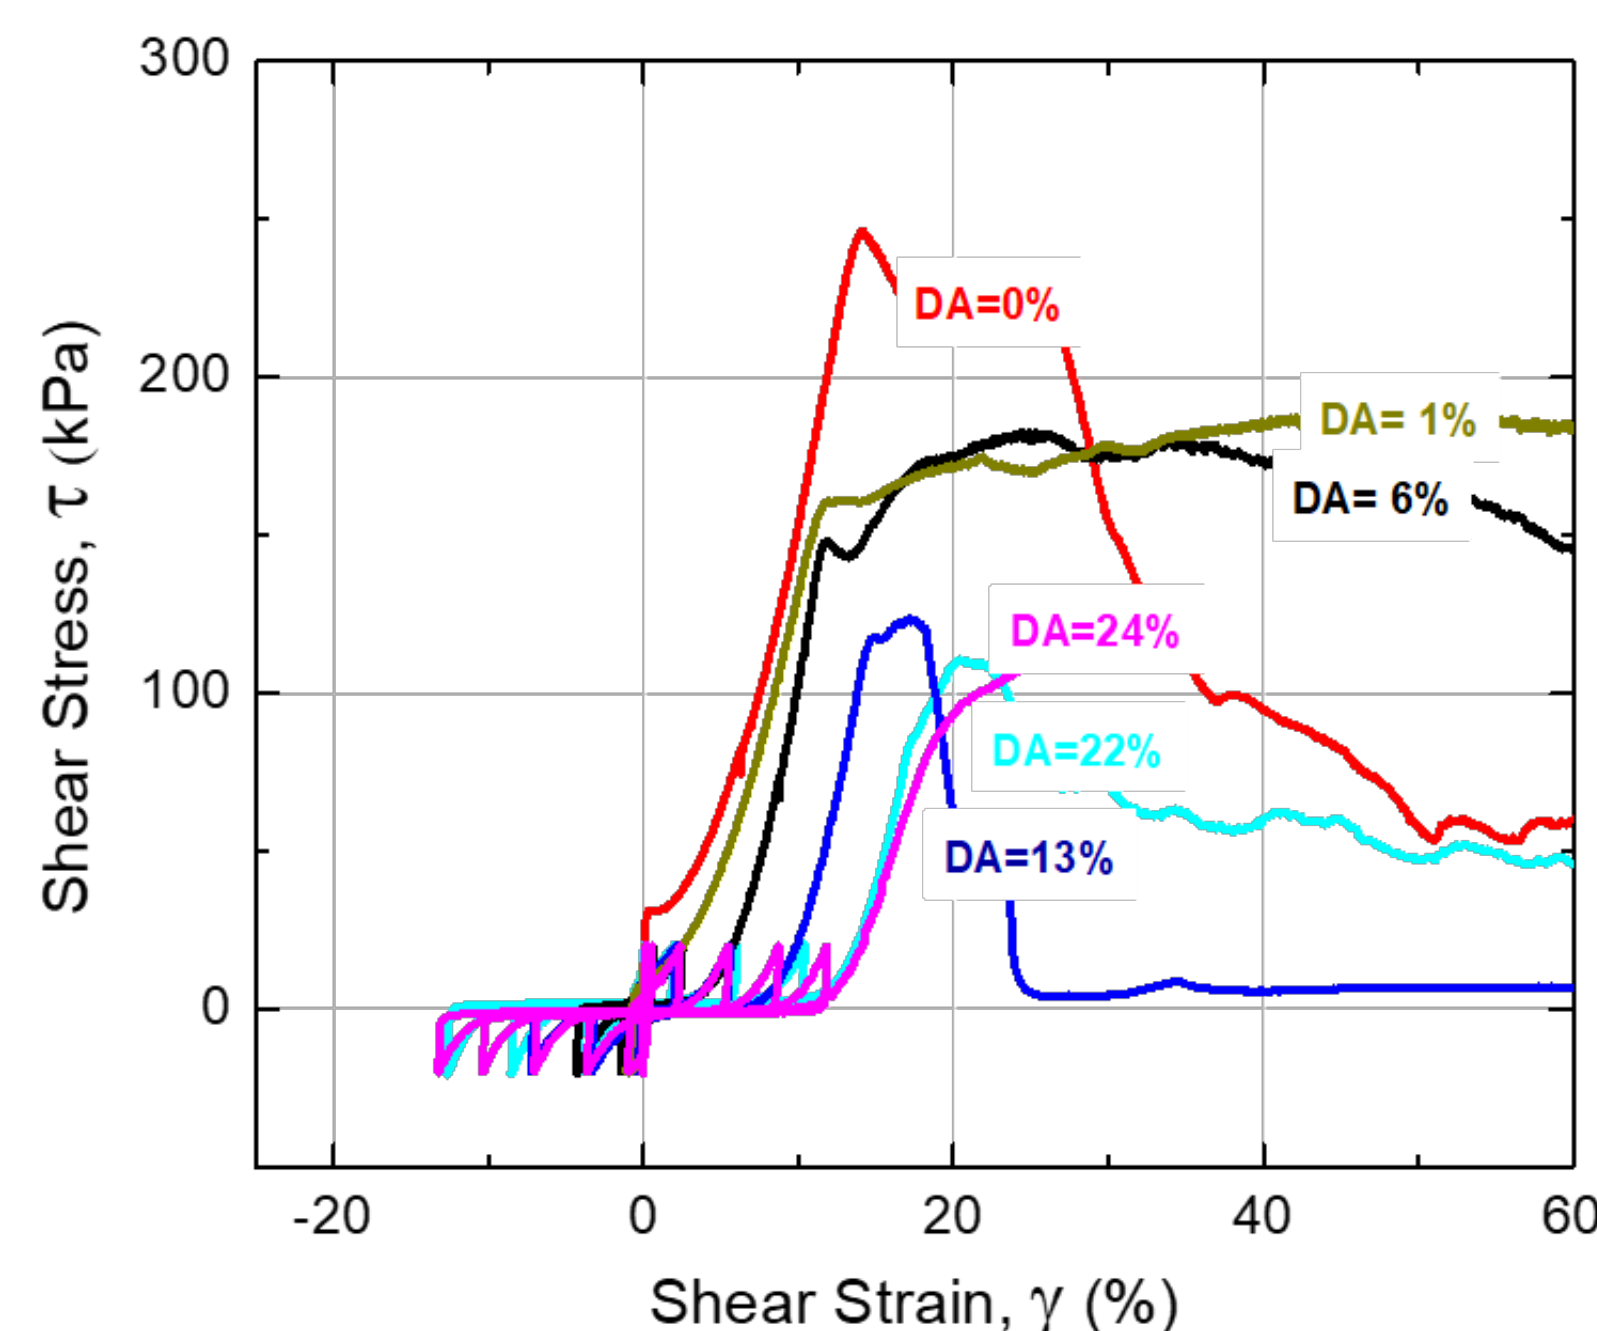
A series of Torsional shear test were performed with different level of cyclic damage strain 1% to 24%

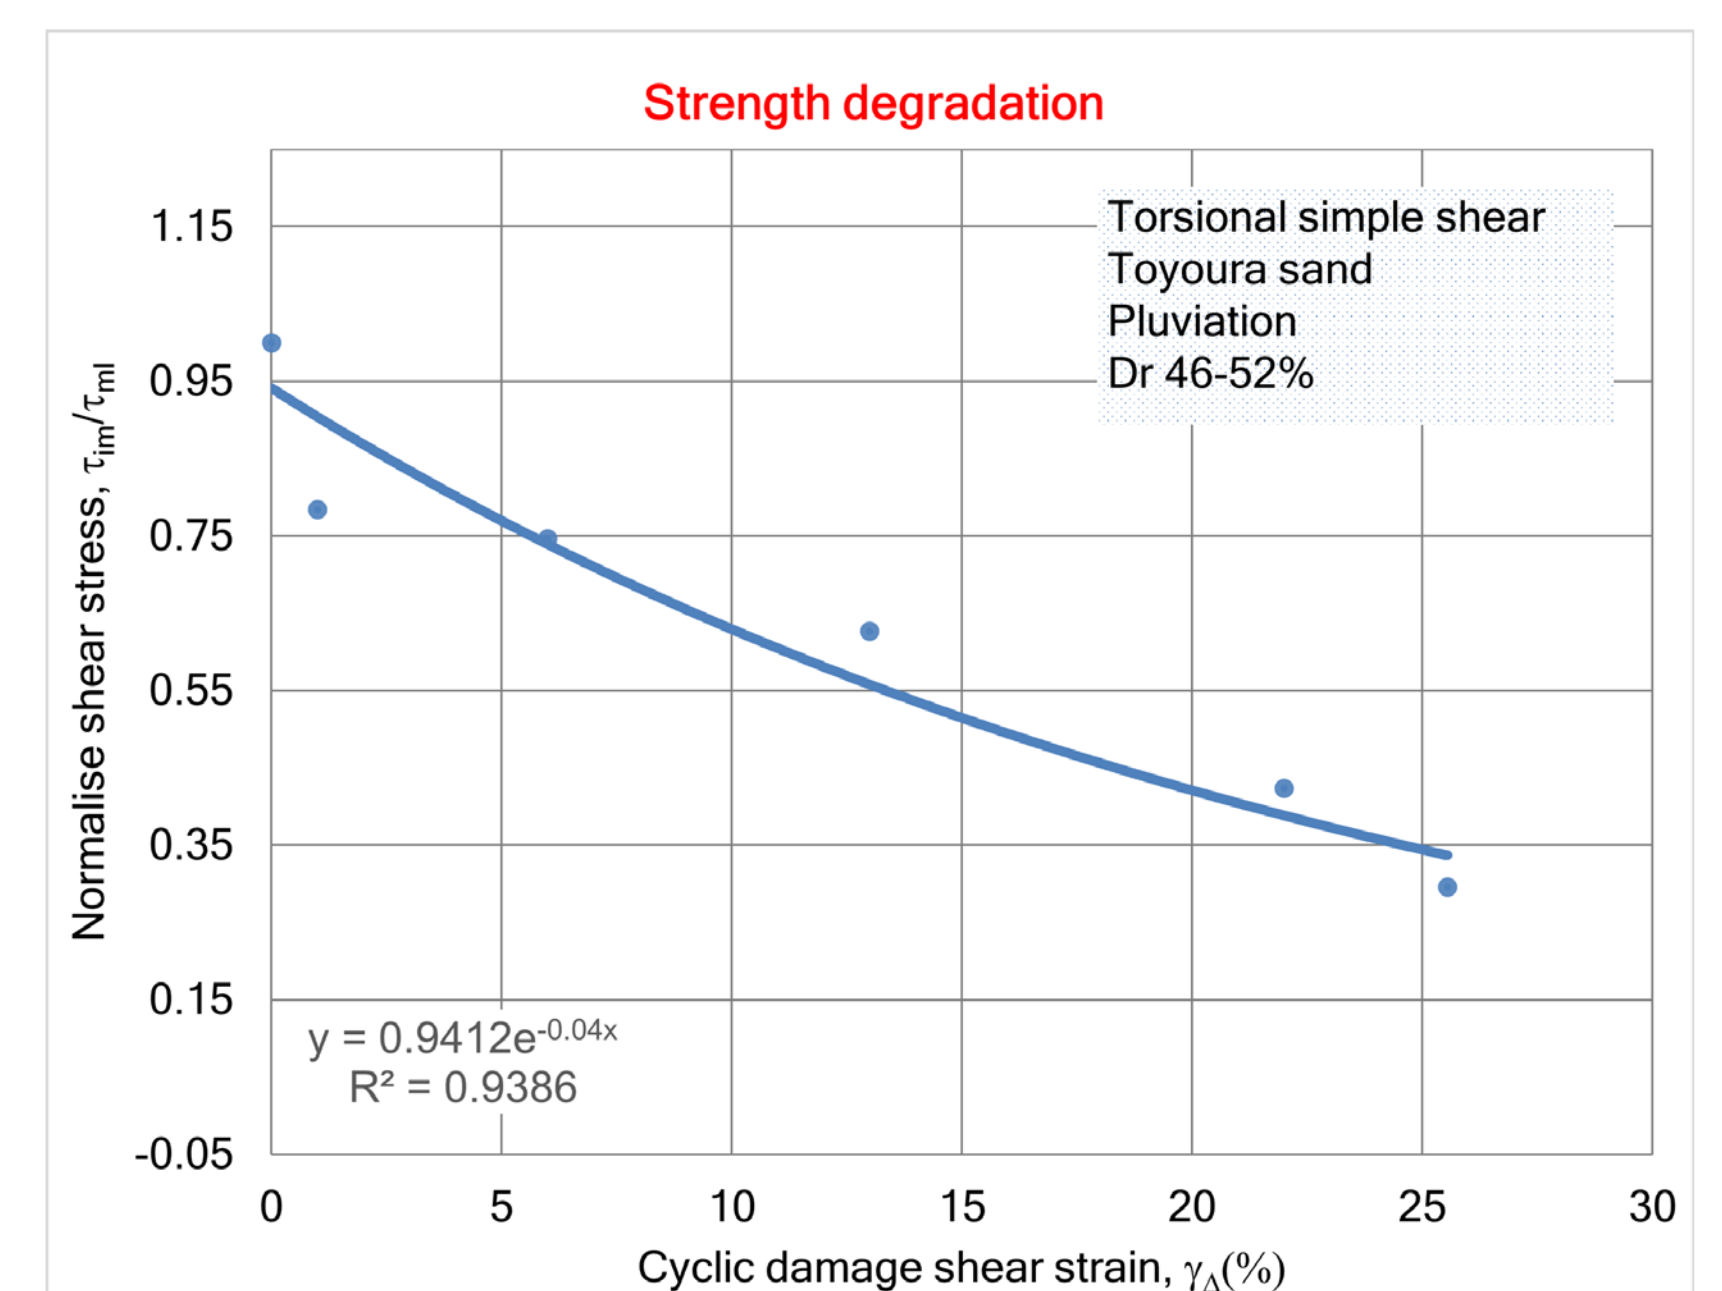
Peak shear strength is normalized by the peak undrained resistance of monotonic test
